Re: Notice of Violation  
Compliance Evaluation Inspection  
MID 048 989 891

ATTACHMENT A  
MPI Inspection Photographs  
MID 048 989 891

Attachment A  
Photographs for MPI RCRA CEI  
MID 048 989 891  
May 15, 2013

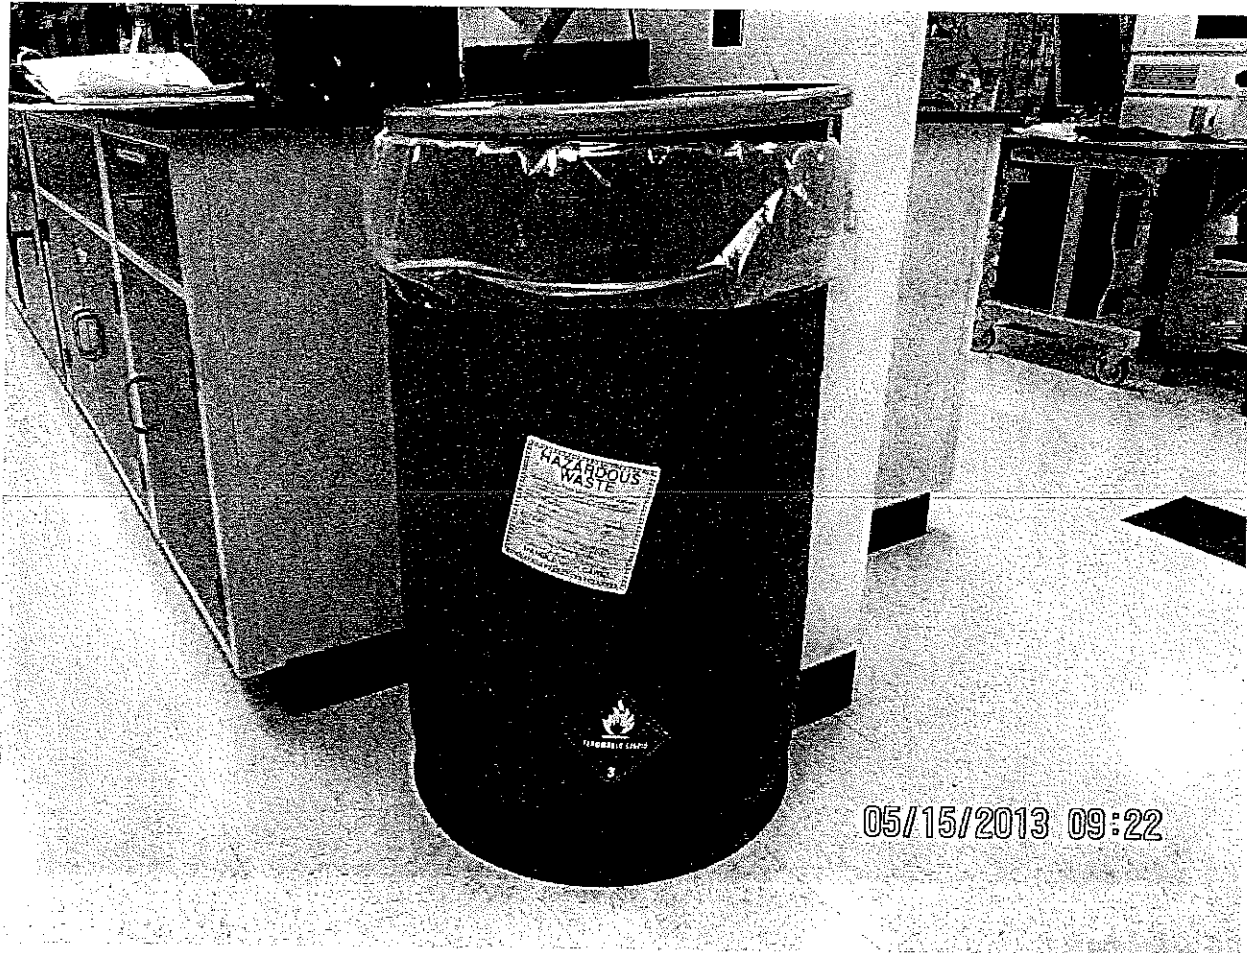
Photograph: #2

Description: A 55-gallon container containing test articles waste (acetone, methanol, xylene - D001, F003) located in the Analytical Area

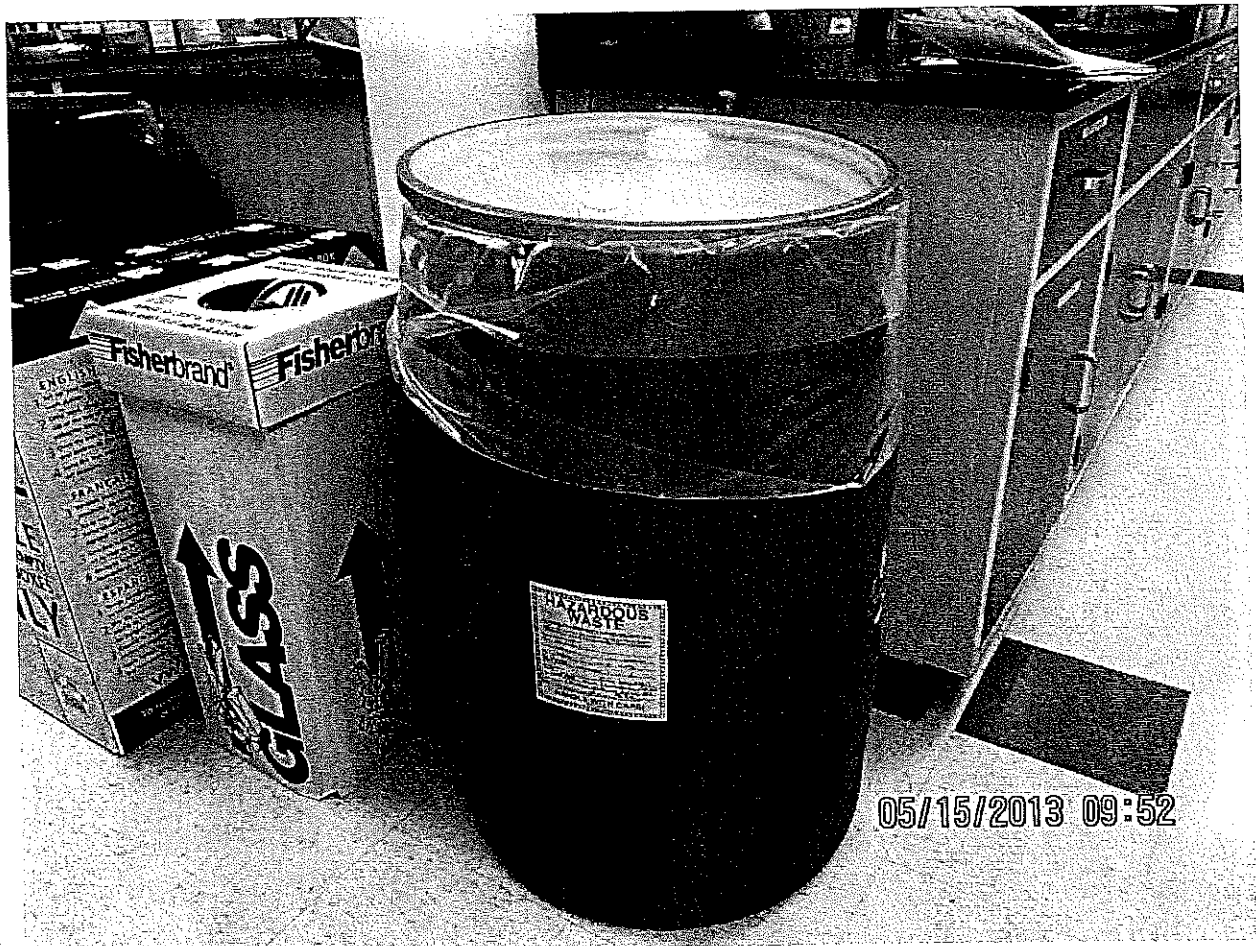
Photograph: #7  
Name of Photographer: Cindy Dabner  
Date/Time of Photograph: May 15, 2013  
Site Location: 54943 North Main Street, Mattawan, MI 49071  
Photograph Location: Instrument Area Room M-2117  
Description: A 55-gallon drum marked with waste codes D001 and F003 and labeled as acetone, methanol, and xylene.

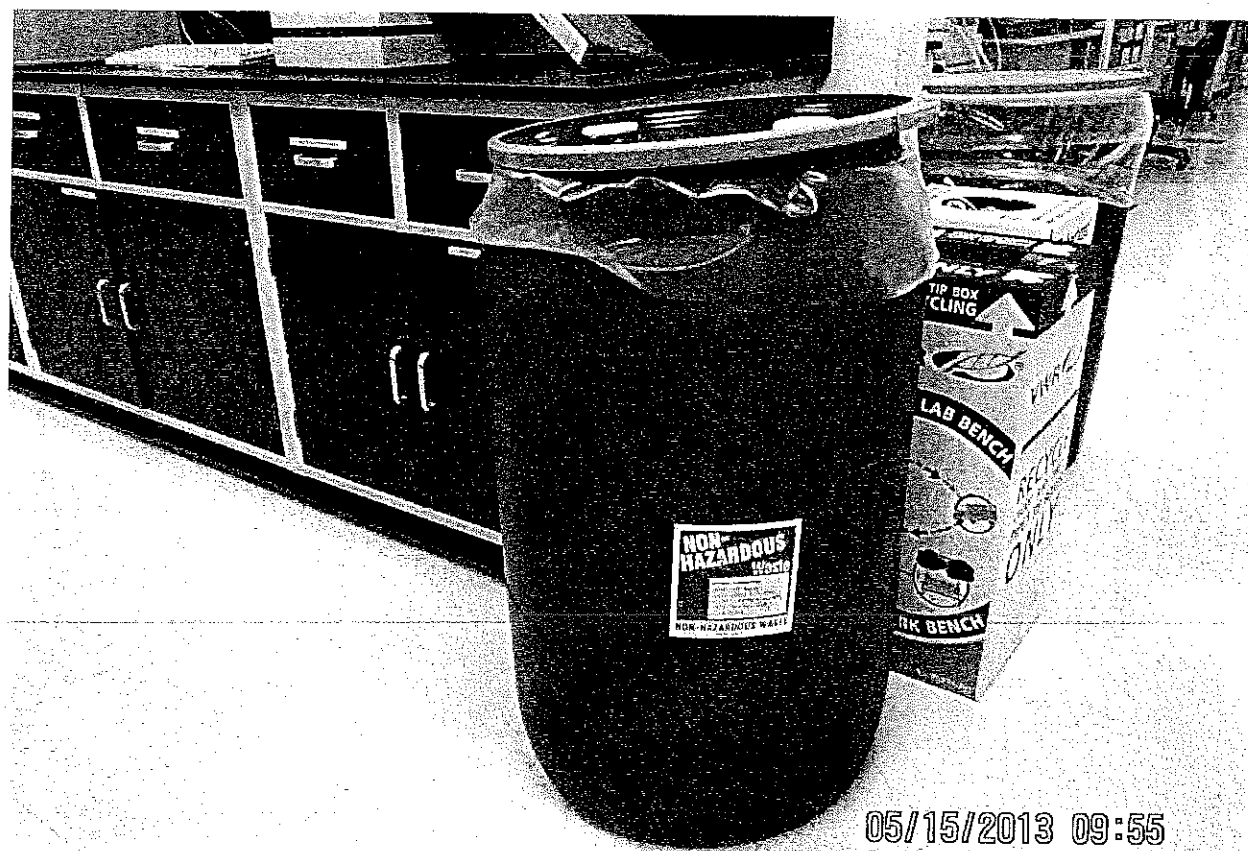
Photograph: #10

Description: A 55-gallon drum of non-hazardous universal pharmaceutical waste marked as TOMTEC Tips Laboratory Waste.

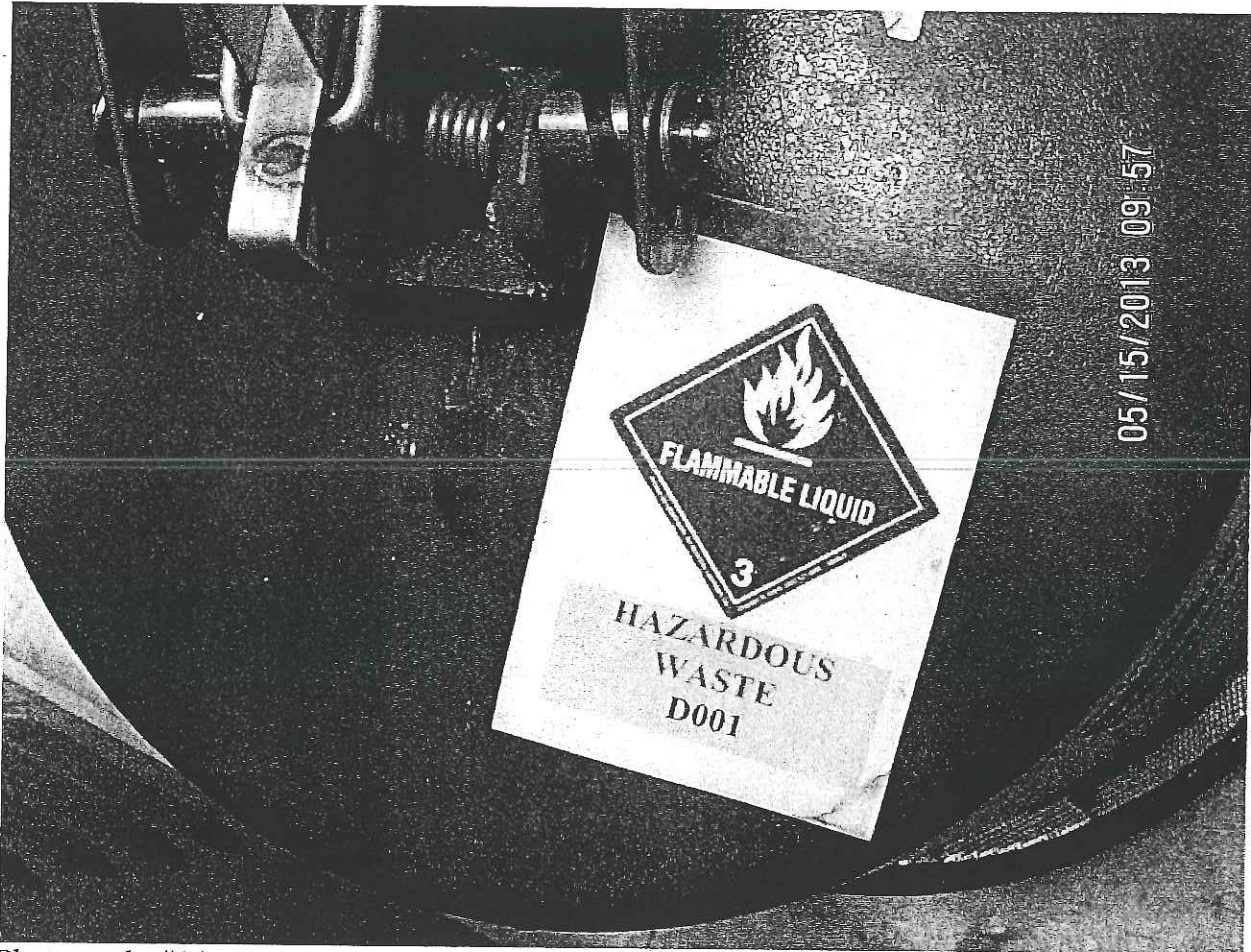
Photograph: #14

Description: A closer picture of the 5 gallon container observed marked as hazardous waste with D001 waste code.

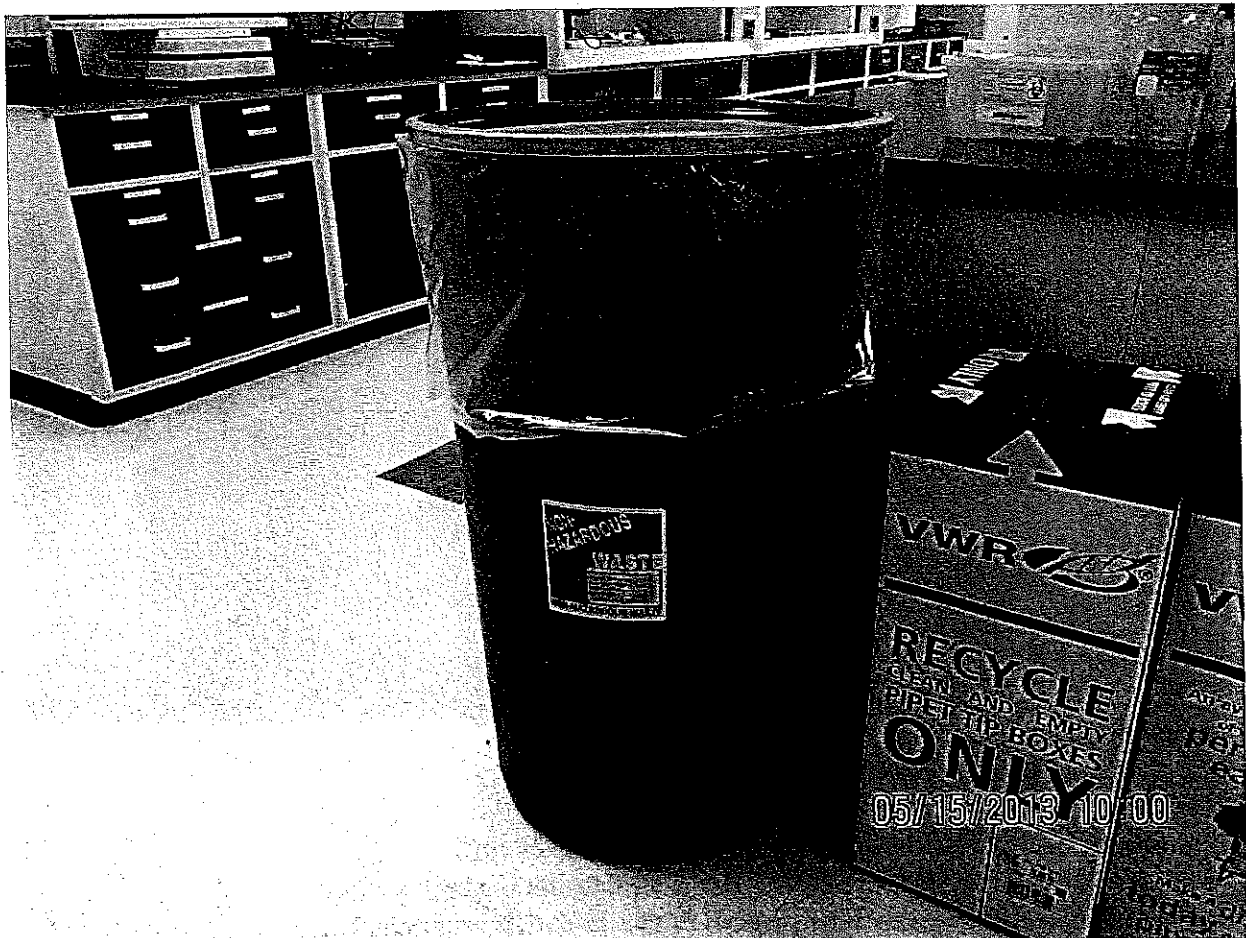
Photograph: #15

Description: Non-hazardous waste with contents marked as TOMTEC Tips Trays.

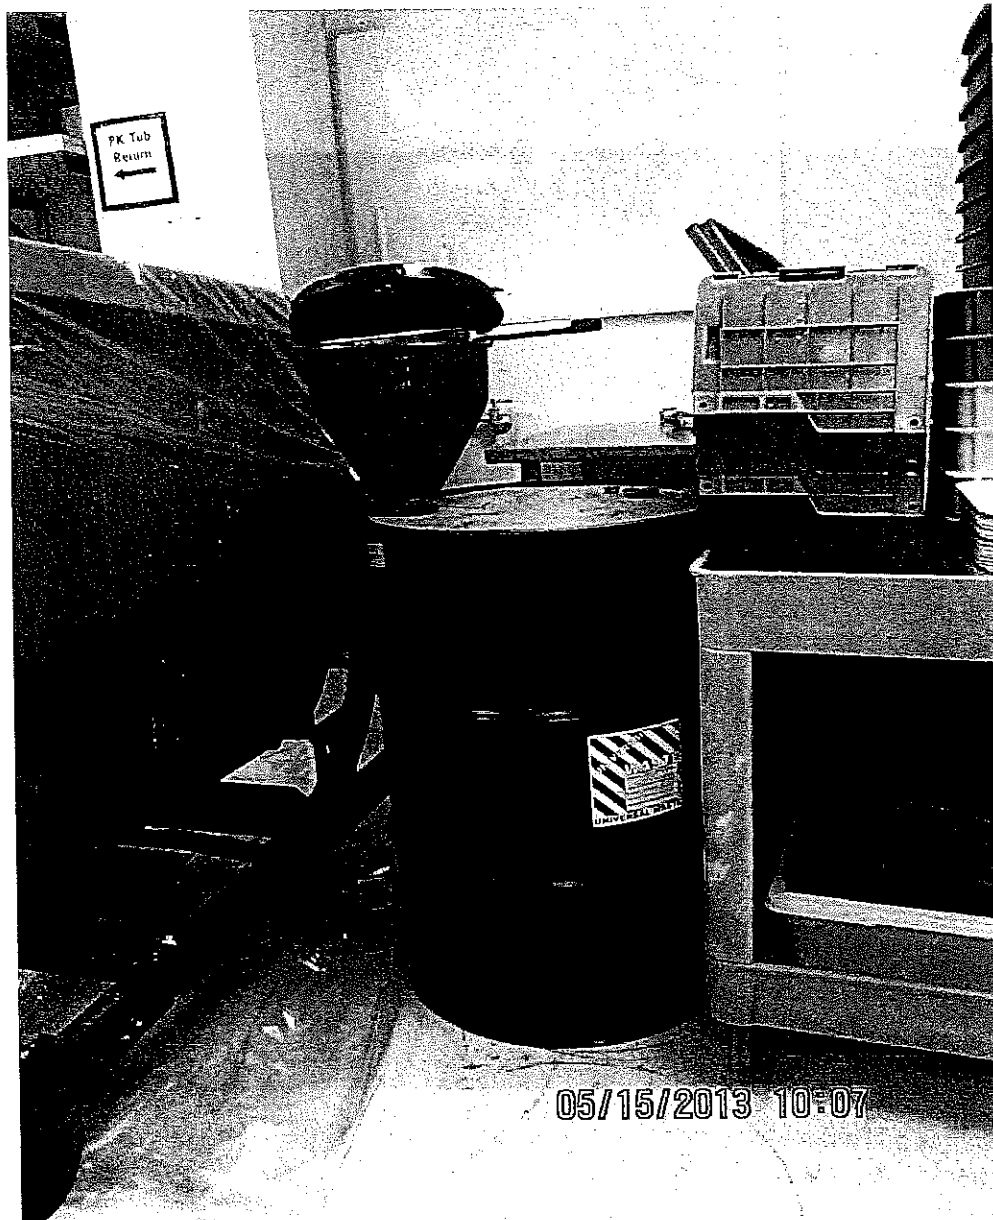
Photograph: #17

At the time of the inspection, one 55-gallon drum located in room M-2467 of the TMC was observed open. MPI Research, therefore, failed to comply with the above-referenced universal waste requirements. However, at the time of the drum was closed. Thus, no further action is necessary for the above-referenced requirement.

Description: Open 55-gallon drum marked as universal pharmaceutical liquid

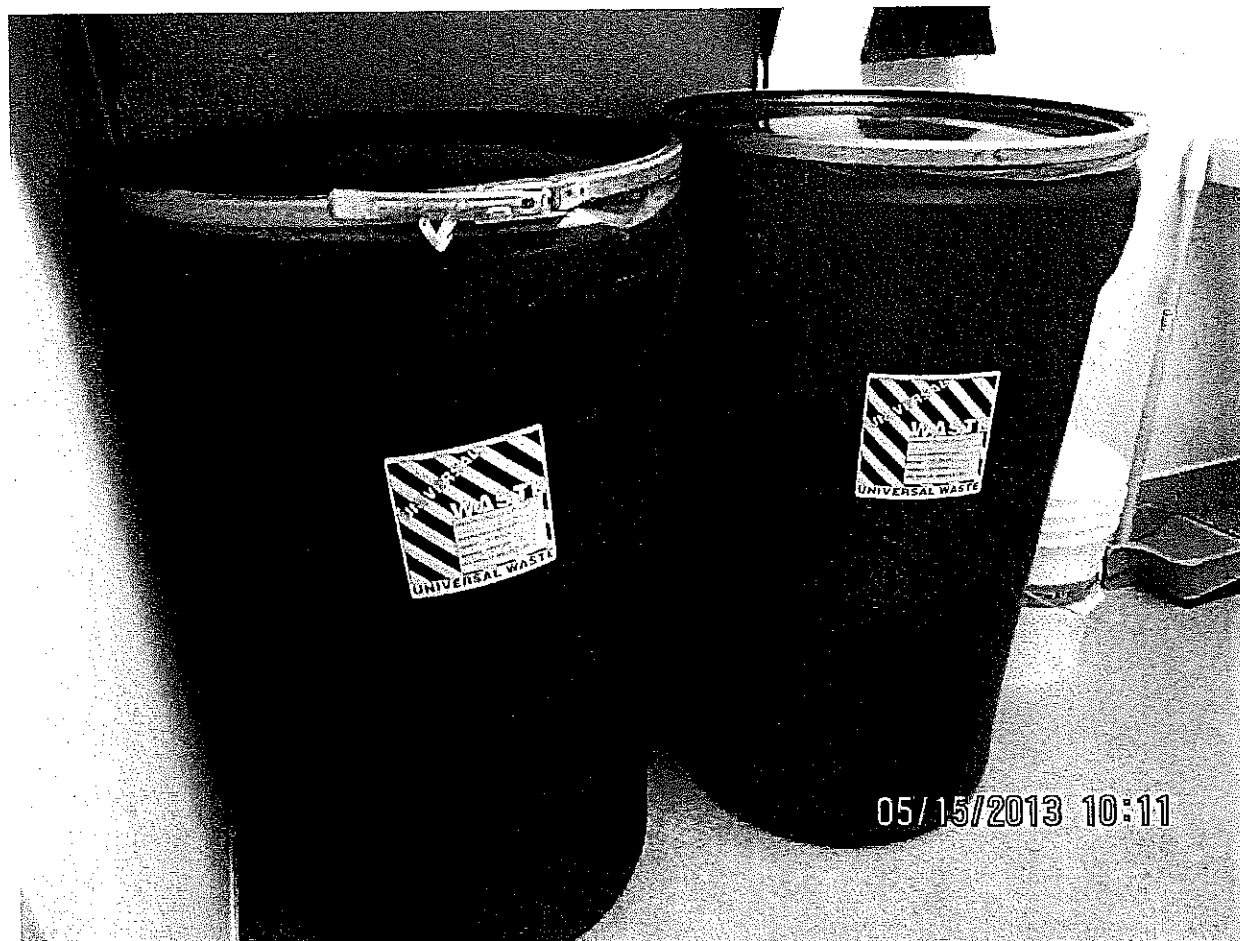
Photograph: #19

At the time of the inspection and following the inspection, MPI Research was unable to demonstrate the length of time that the universal waste has been accumulated from the date it becomes a waste or was received. MPI Research personnel provided a start date for the lamps, but an accumulation start date for the pharmaceutical waste was not provided. MPI Research, therefore, failed to comply with the above-referenced universal waste requirements.

Description: Two 55-gallon drums marked as universal pharmaceutical solids were observed closed and not marked with the accumulation start date.

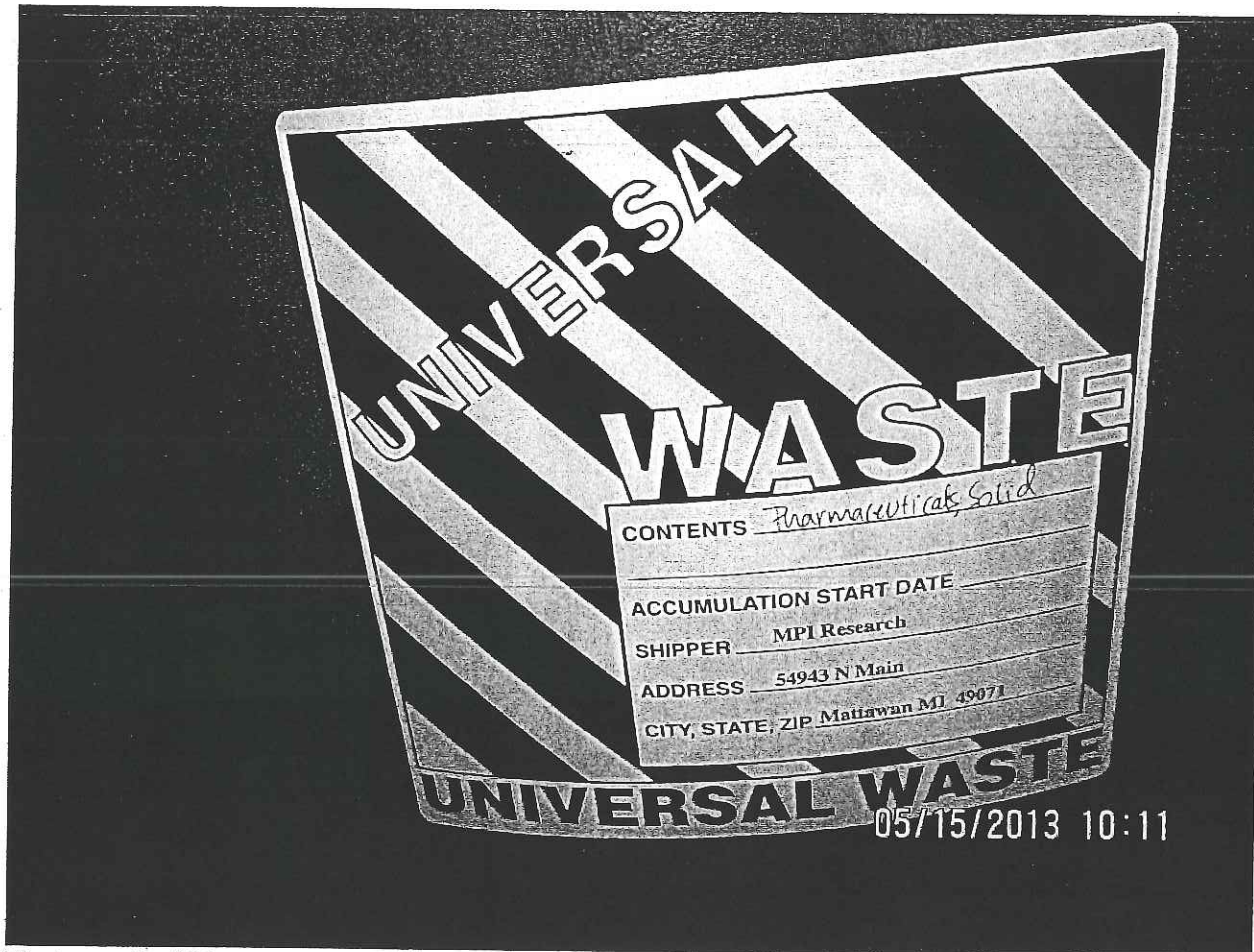
Photograph: #20

Description: A closer picture of a 55-gallon drum marked as universal pharmaceutical solid was observed closed without an accumulation start date.

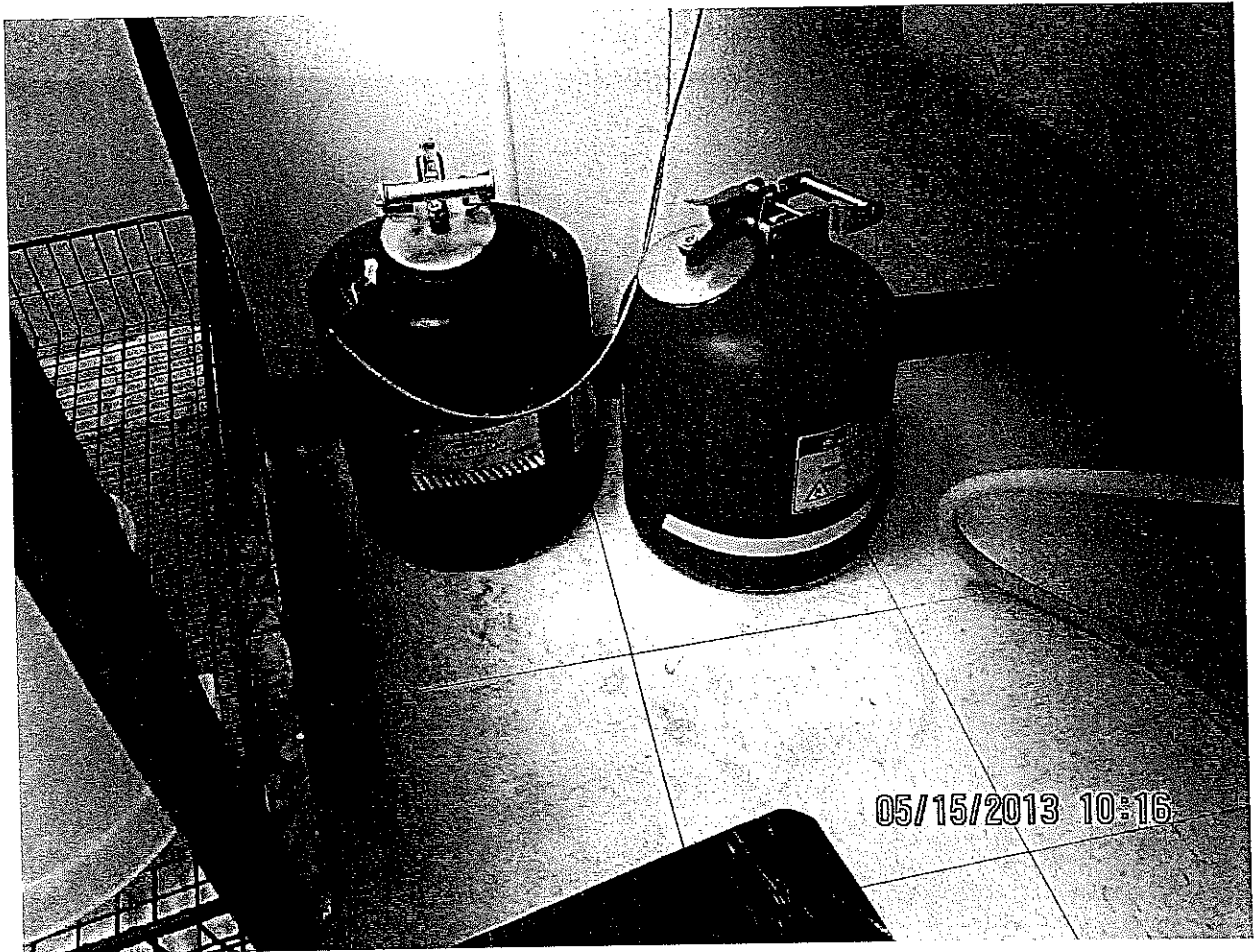
Photograph: #21

2514 of the Test Material Control Area (TMC) containing acetone was observed not marked as a hazardous waste with the hazardous waste codes;

Description: Two 5-gallon containers observed not labeled as hazardous waste and not marked with hazardous waste codes.

MPI Research, therefore, violated the above-reference storage container management requirement. However at the time of the inspection, facility personnel provided hazardous waste labels were provided with the hazardous waste codes. Thus, no further action is necessary for the above-referenced requirement.

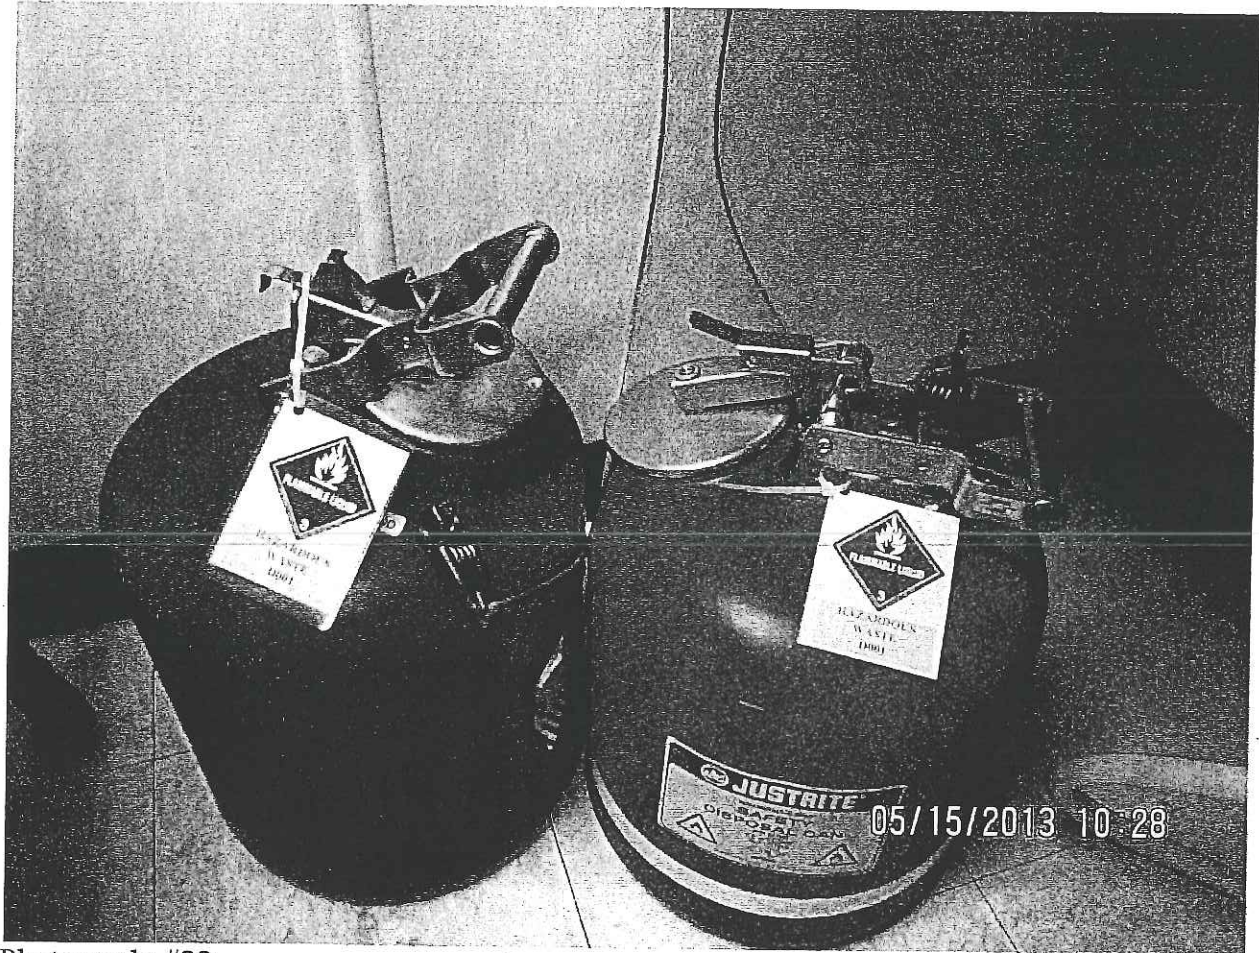
Photograph: #22

Description: Two 5-gallon containers labeled as hazardous waste and marked with hazardous waste codes at the time of the inspection.

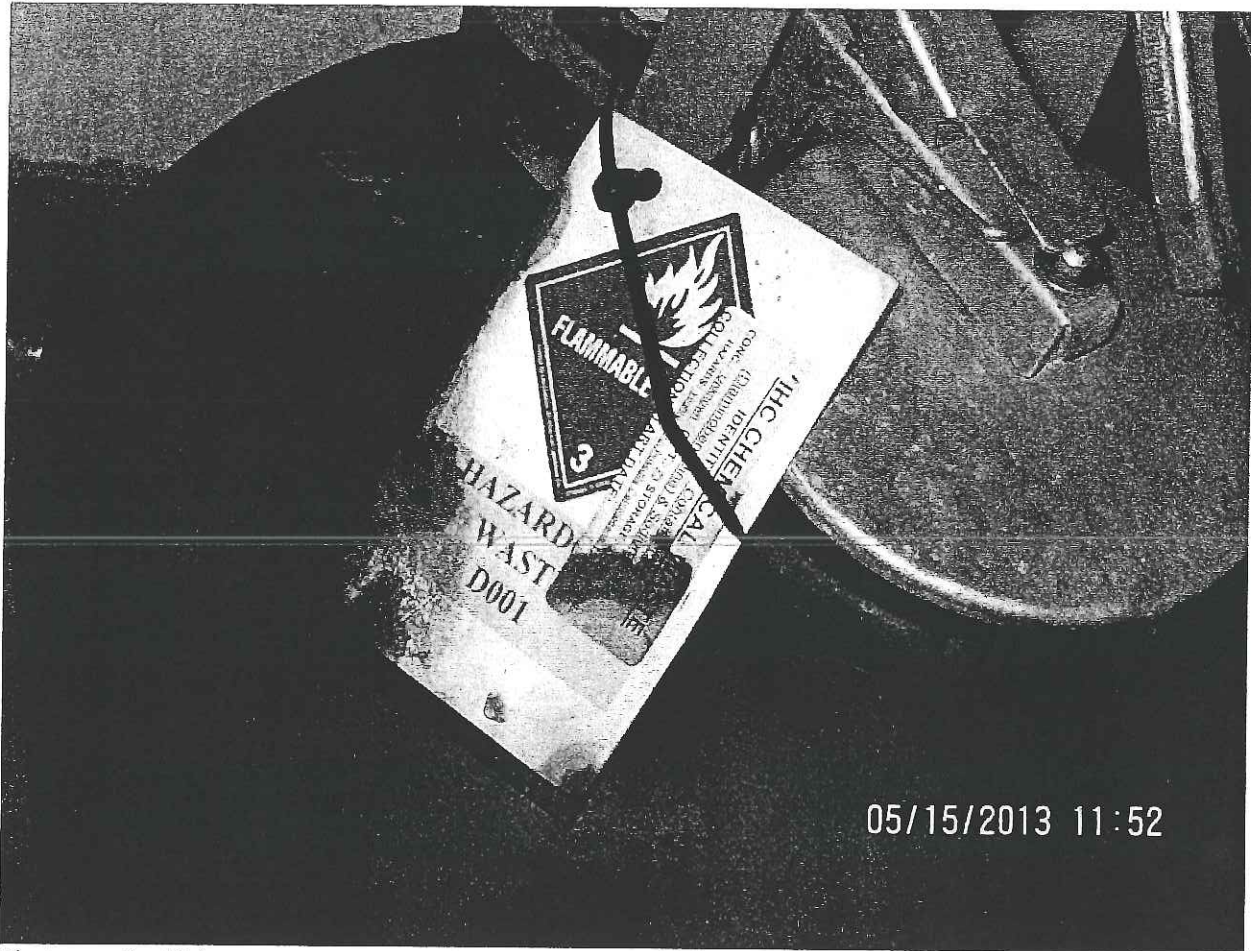
Photograph: #24

Description: A closer picture of the 5-gallon container shown in photograph #23

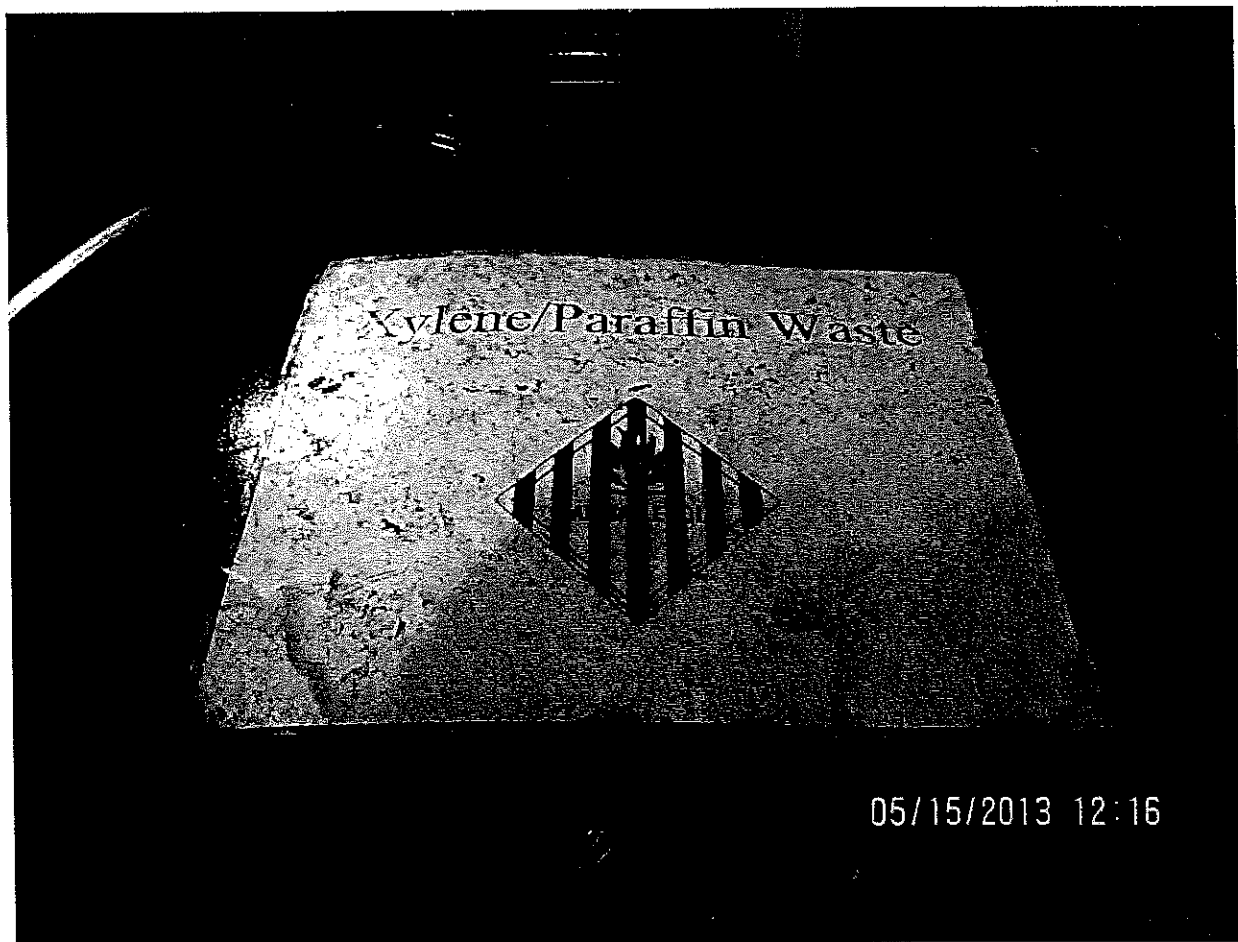
Photograph: #35

Description: Top view of 55 gallon drum located in the Drum Room was observed labeled as a xylene/ paraffin waste and a flammable solid.

Another 55-gallon drum located in the Drum Room was observed labeled as a xylene/ paraffin waste and a flammable solid, but not as a hazardous waste with waste codes. See Photograph #35 and #36. The 55-gallon drum served as a SAA for one of the nearby Laboratories. A hazardous waste label marked with hazardous waste codes D001 and F003 was placed on the drum at the time of the inspection. The DOT shipping information and UN was also provided at the time of the inspection. See Photograph #37 and #38.

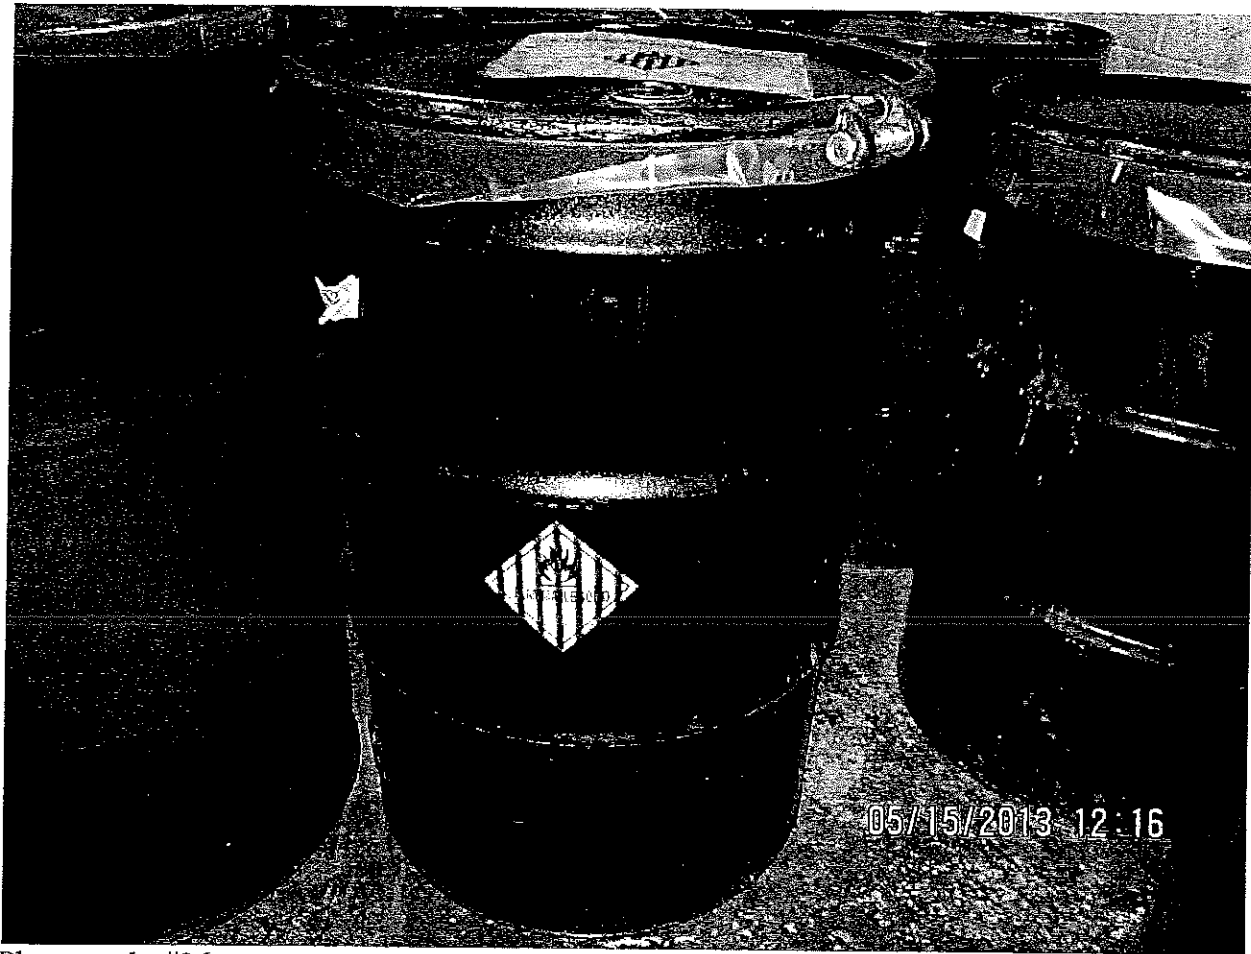
Photograph: #36

Description: 55 gallon drum located in the Drum Room was observed labeled as a xylene/paraffin waste and a flammable solid.

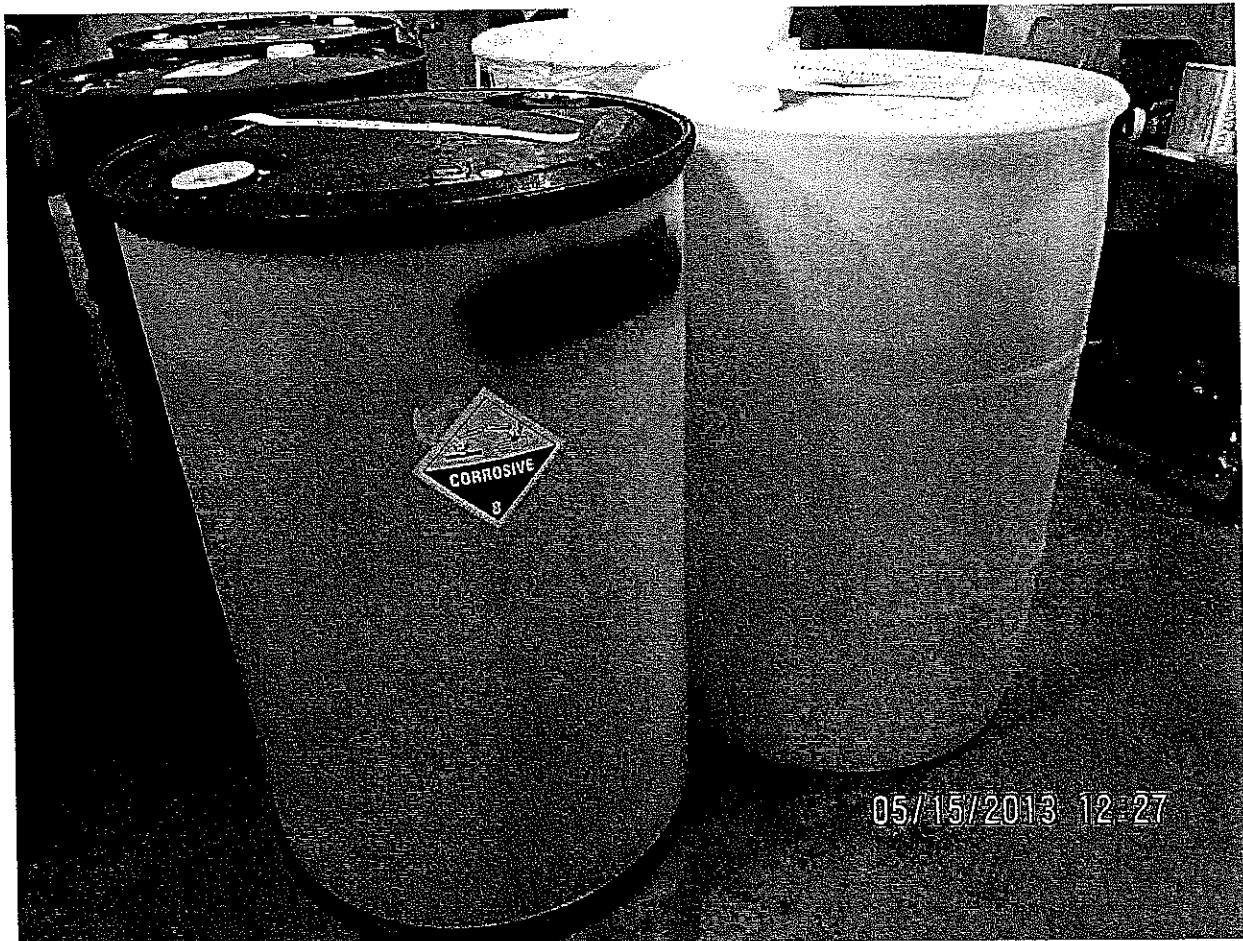
Photograph: #39

Description: Two 55 gallon drum observed not marked as hazardous waste with the hazardous waste codes.

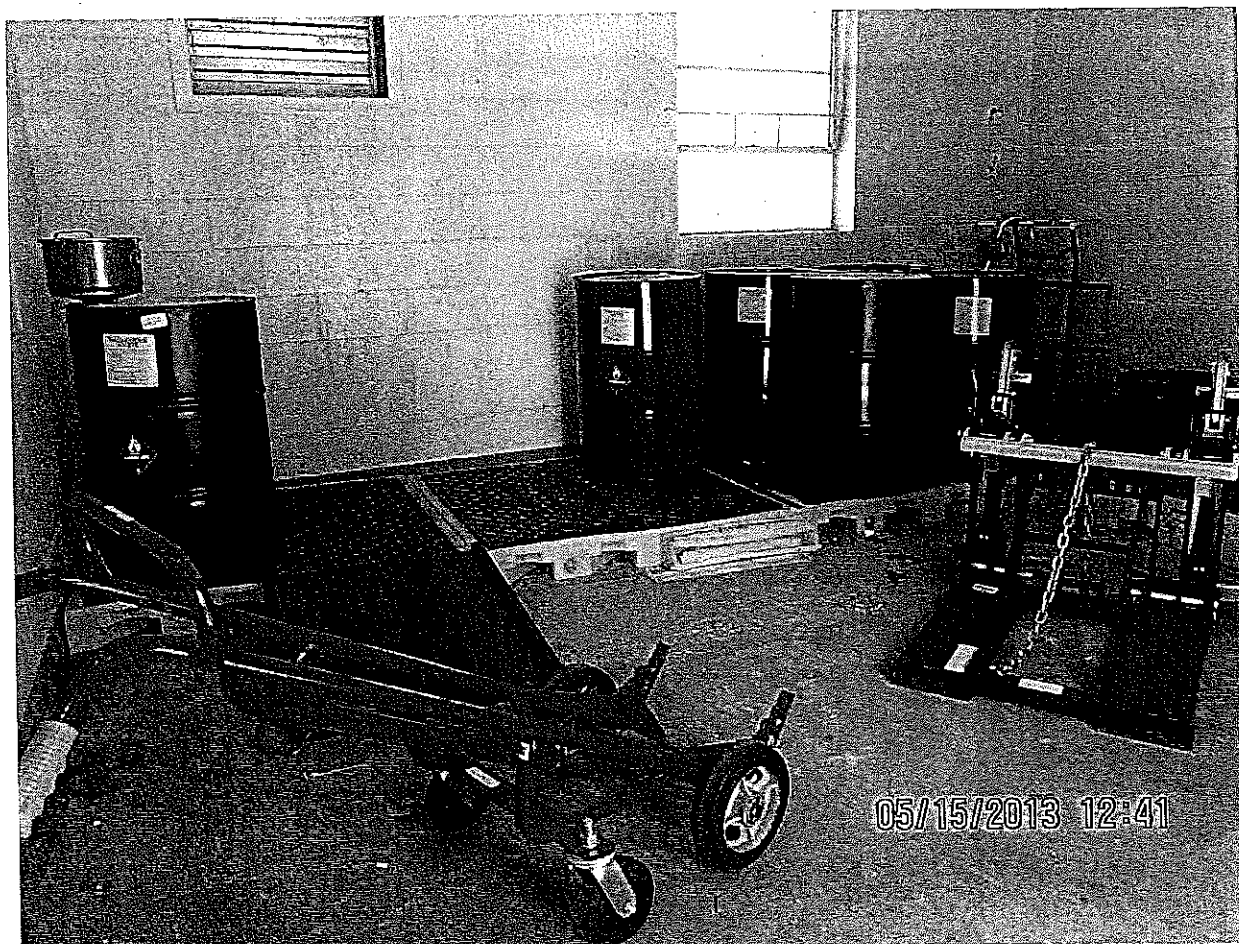
Photograph: #45

Photograph Location: 90 Day Accumulation Area of the Hazardous Waste Building

Description: Hazardous Waste Storage Area

The tour moved to the Hazardous Waste Storage Building. See Photograph #45. This building serves as a 90 Day Accumulation Storage Area and SAA. Several 55-gallon drums were observed marked as hazardous waste with accumulation start dates less than 90 days and hazardous waste codes of D001 and F003. See Photograph #46 and #47.

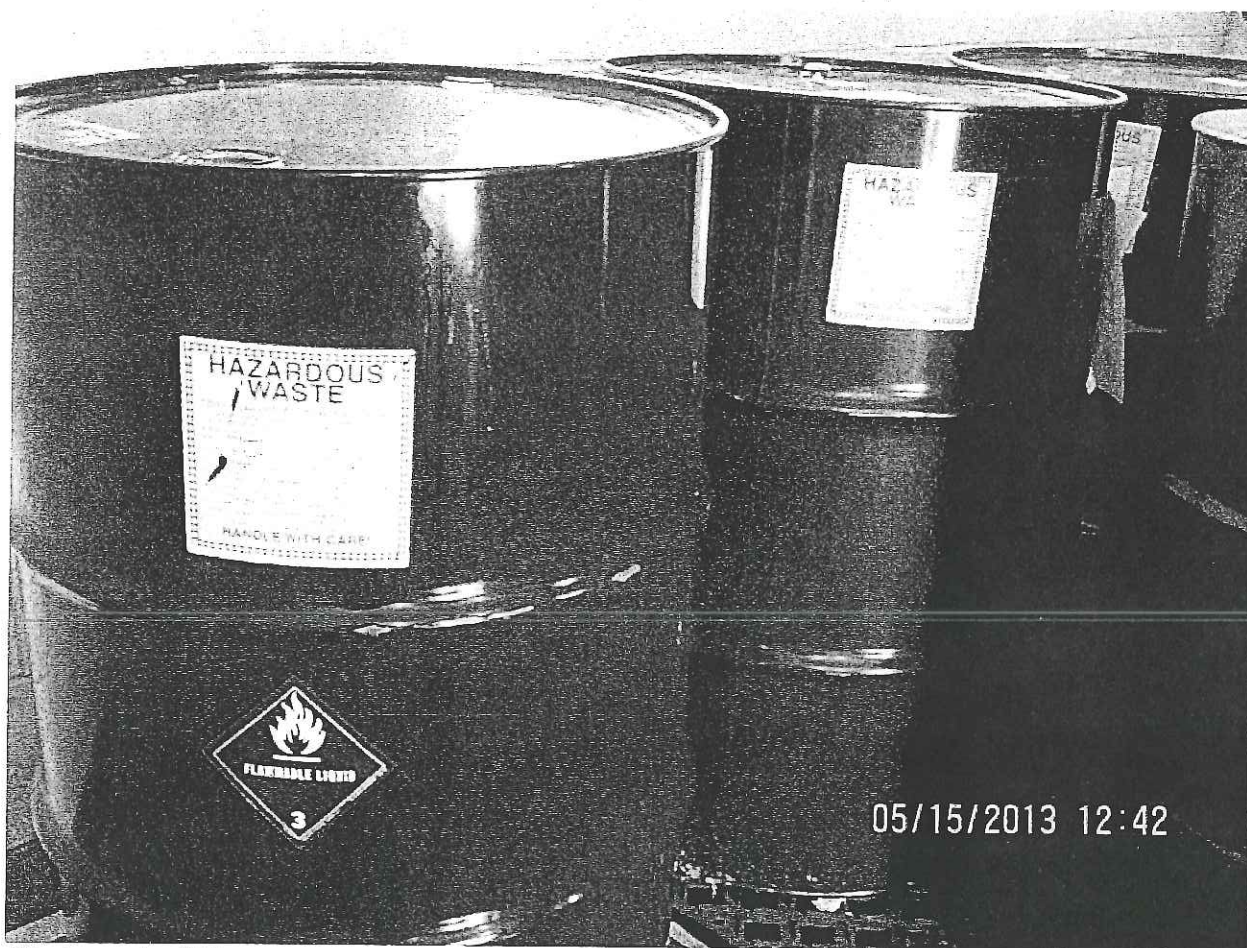
Photograph: #46

Photograph Location: 90 Day Accumulation Area of the Hazardous Waste Building

Description: Several 55 gallon drums were observed marked as hazardous waste in the Hazardous Waste Storage Area

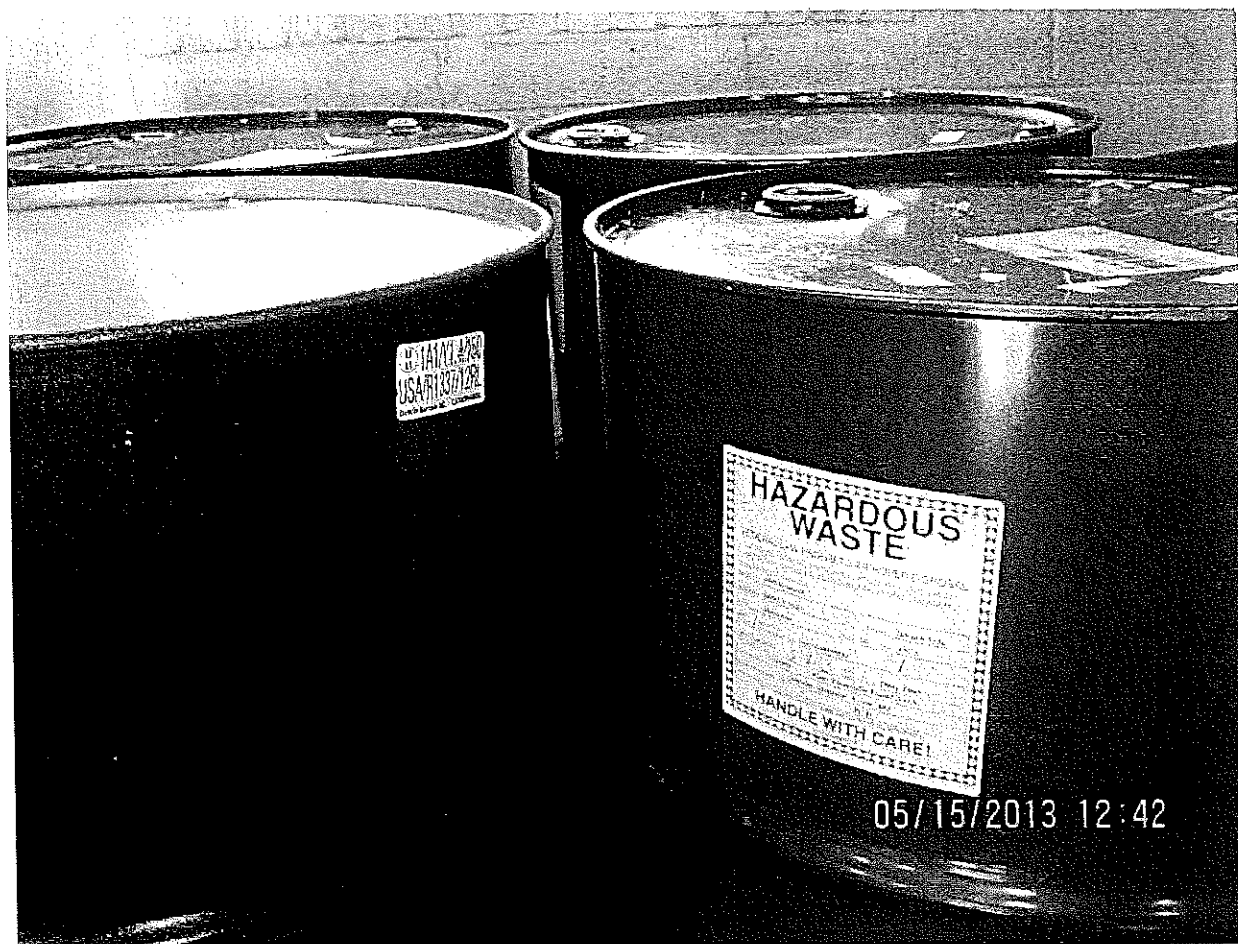
Photograph: #47

Photograph Location: 90 Day Accumulation Area of the Hazardous Waste Building

Description: Several 55 gallon drums were observed marked as hazardous waste in the Hazardous Waste Storage Area

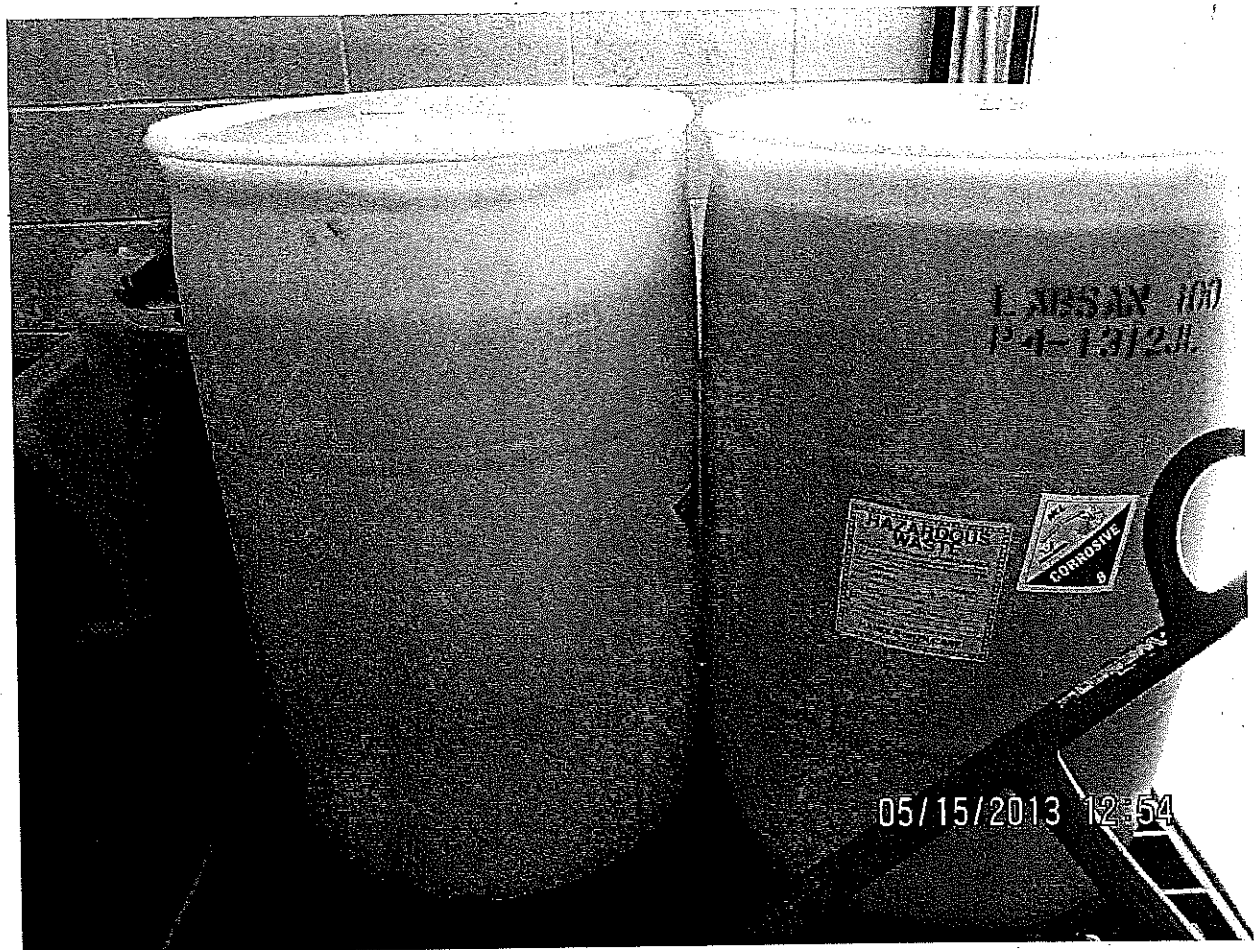
Photograph: #49

Photograph Location: 90 Day Accumulation Area of the Hazardous Waste Building

Description: Container not marked and labeled with contents of waste (hydrochloric acid)

Also located in the 90 Day Hazardous Waste Storage Building, two plastic 55-gallon drums were observed. One drum was marked as a hazardous waste with an accumulation start date of 5/3/2013. The DOT shipping information was listed as potassium hydroxide. The second drum was observed marked only as a corrosive. No hazardous waste label with an accumulation start date was provided. See Photograph #49. A hazardous waste label was placed on the drum at the
